# **2018-2019 CAPITAL BUDGET REQUEST**

## **REPAIRS TO DAMAGED GRANITE ARCH STRUCTURES IN WESTMORELAND AND WALPOLE**

**On the NH DOT owned  
Cheshire Branch railroad corridor**

**February 28, 2017**

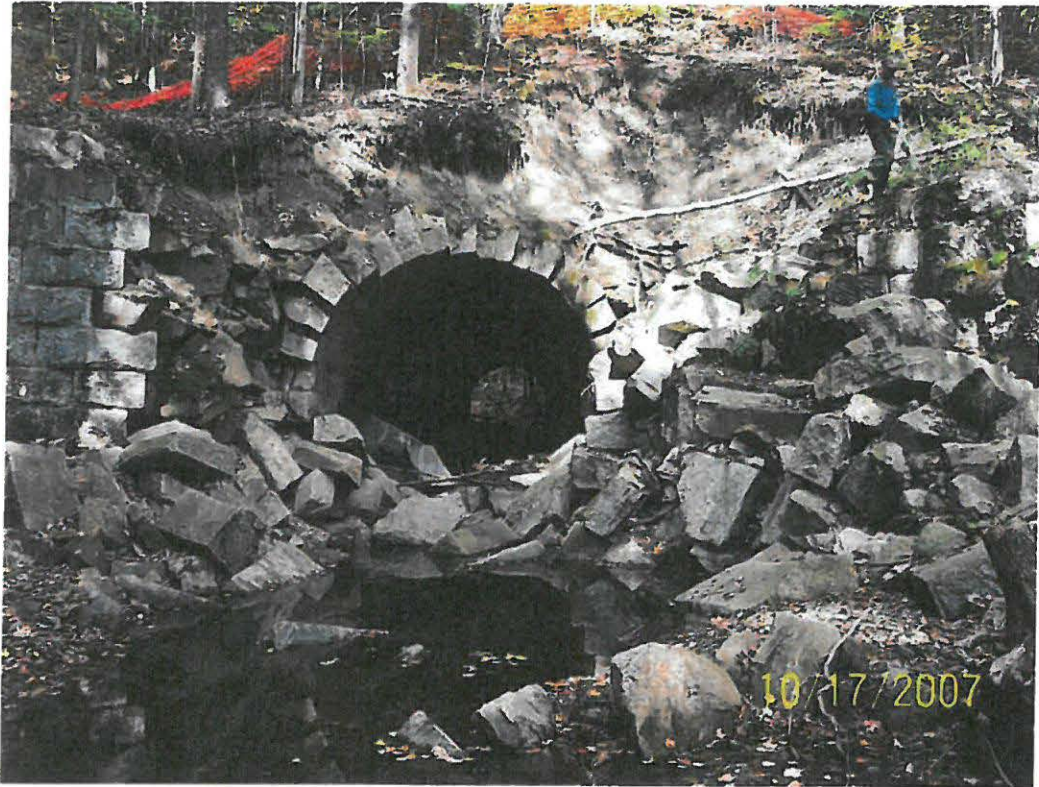
**View of 2007 Arch Collapse**

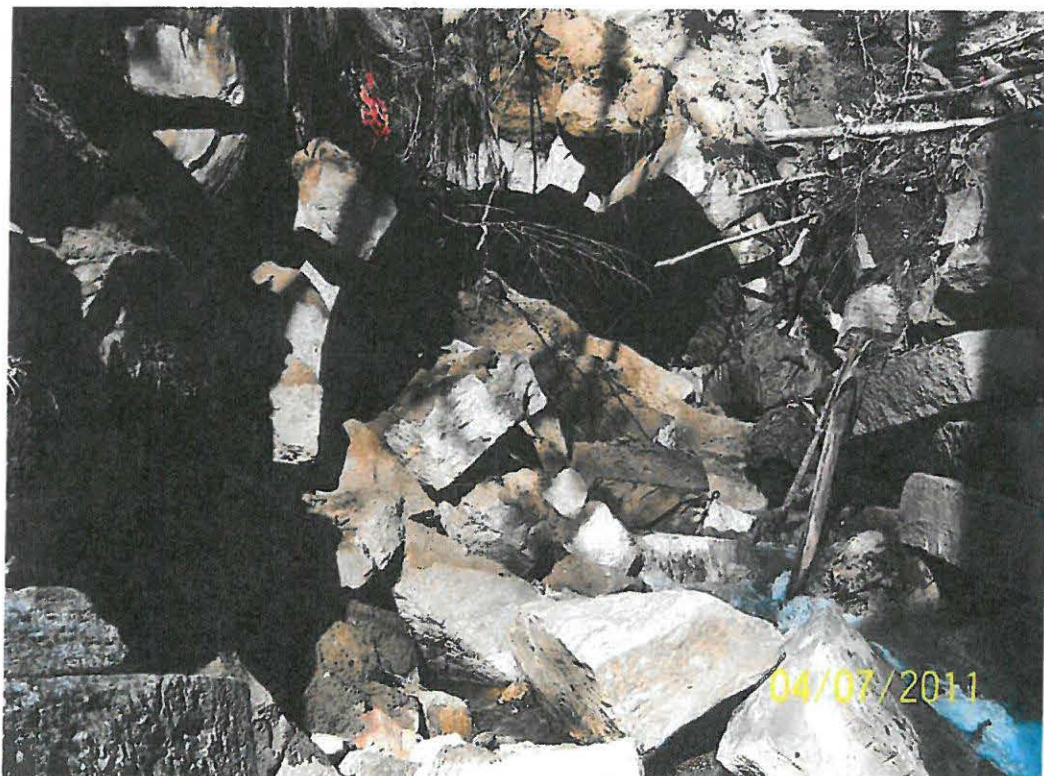
**View of 2011 Arch Collapse**

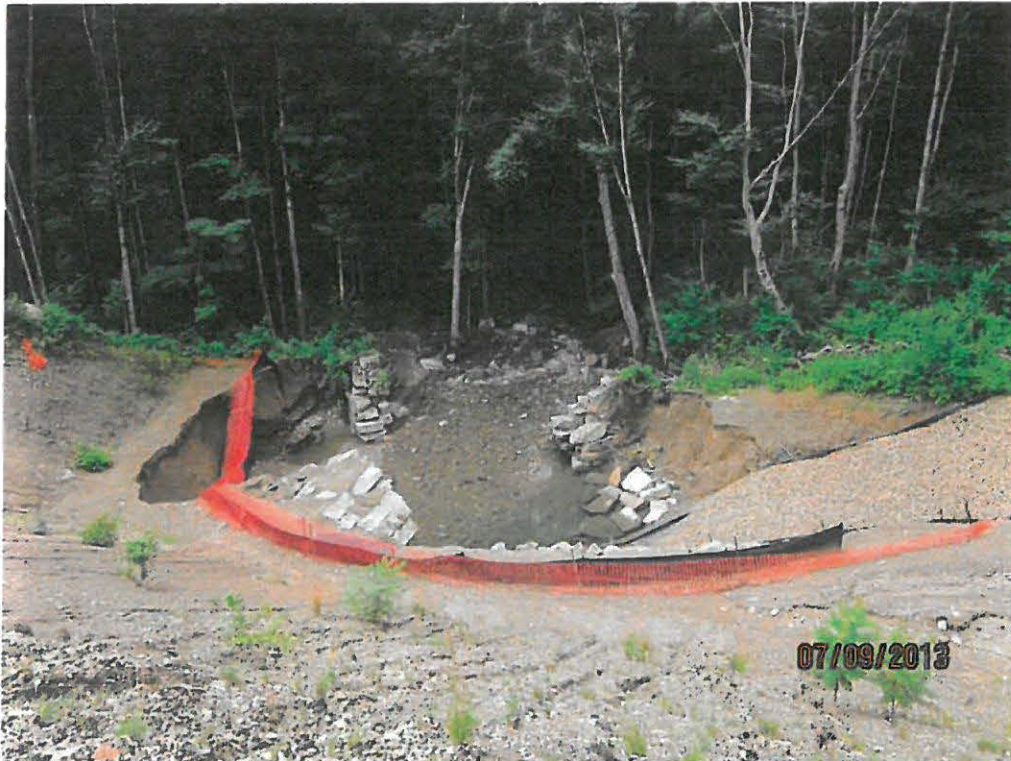
**View of Arch Damage from July 2013 Storm**

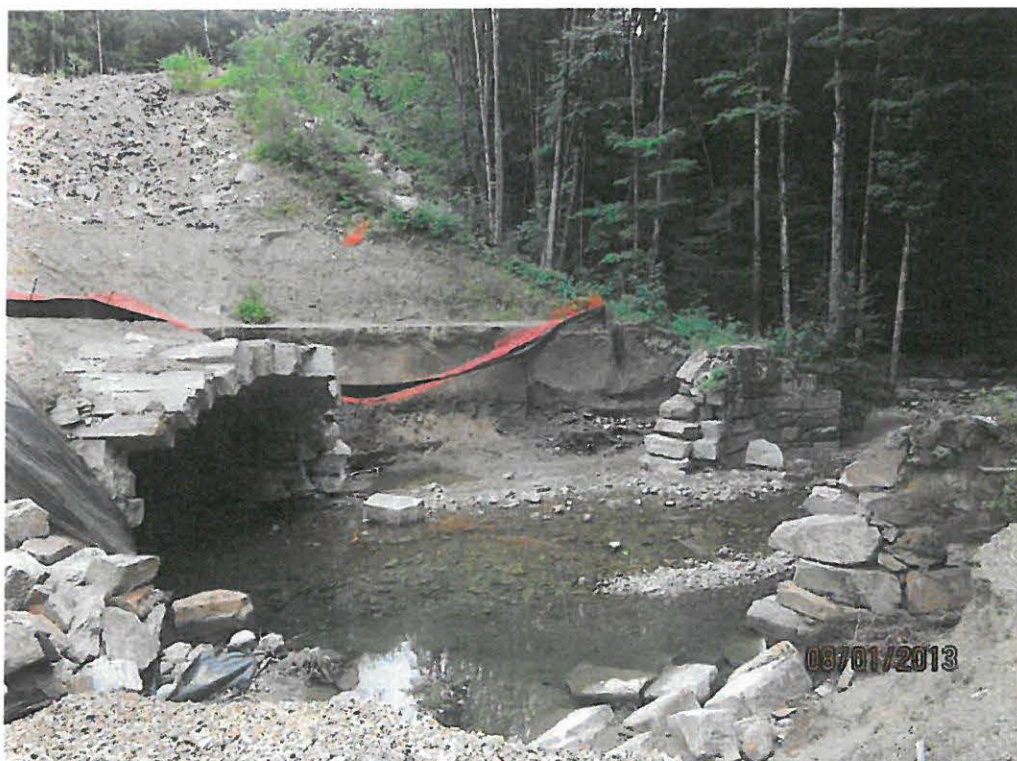
**Close-up View of Arch Damage from July 2013 Storm**

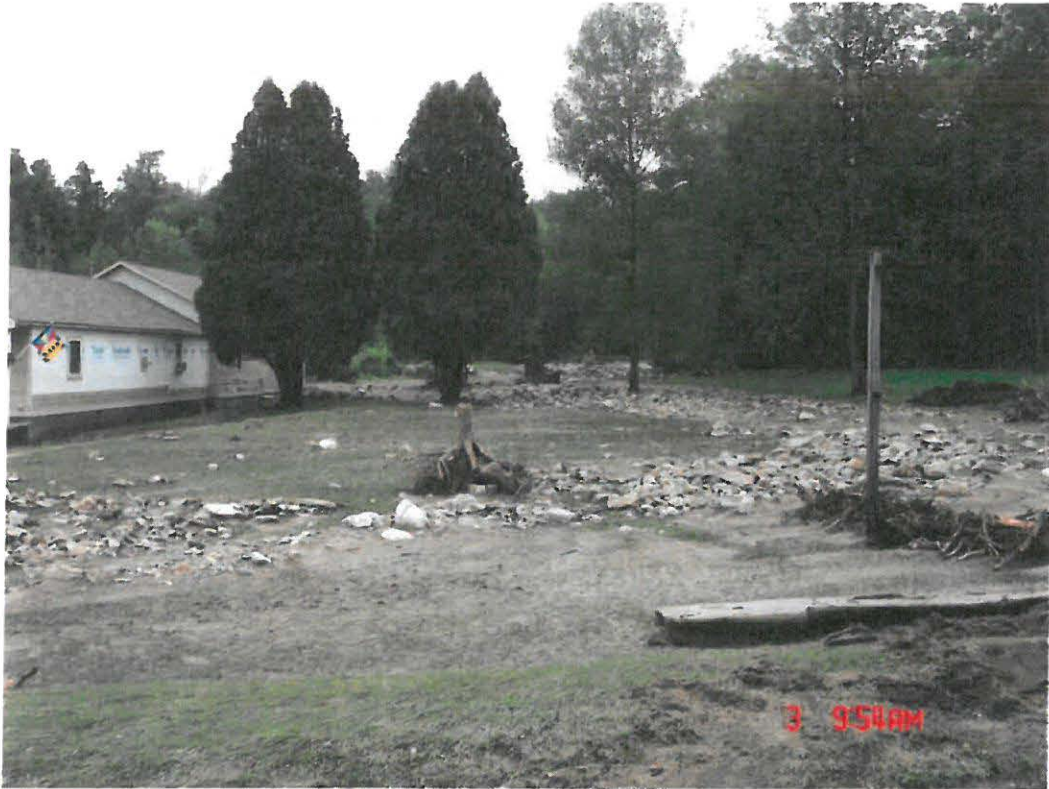
**View of Downstream Flood Damage at Route 12 from July 2013 Storm**

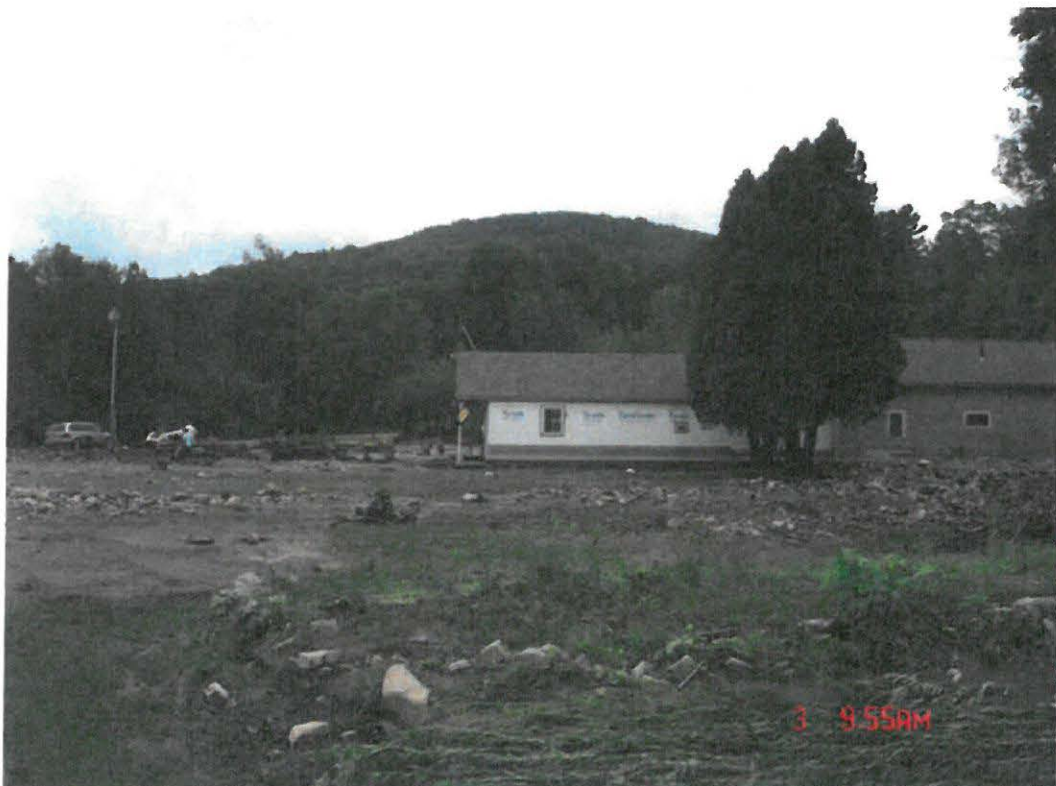
**View of Downstream Flood Damage at Route 12 from July 2013 Storm**

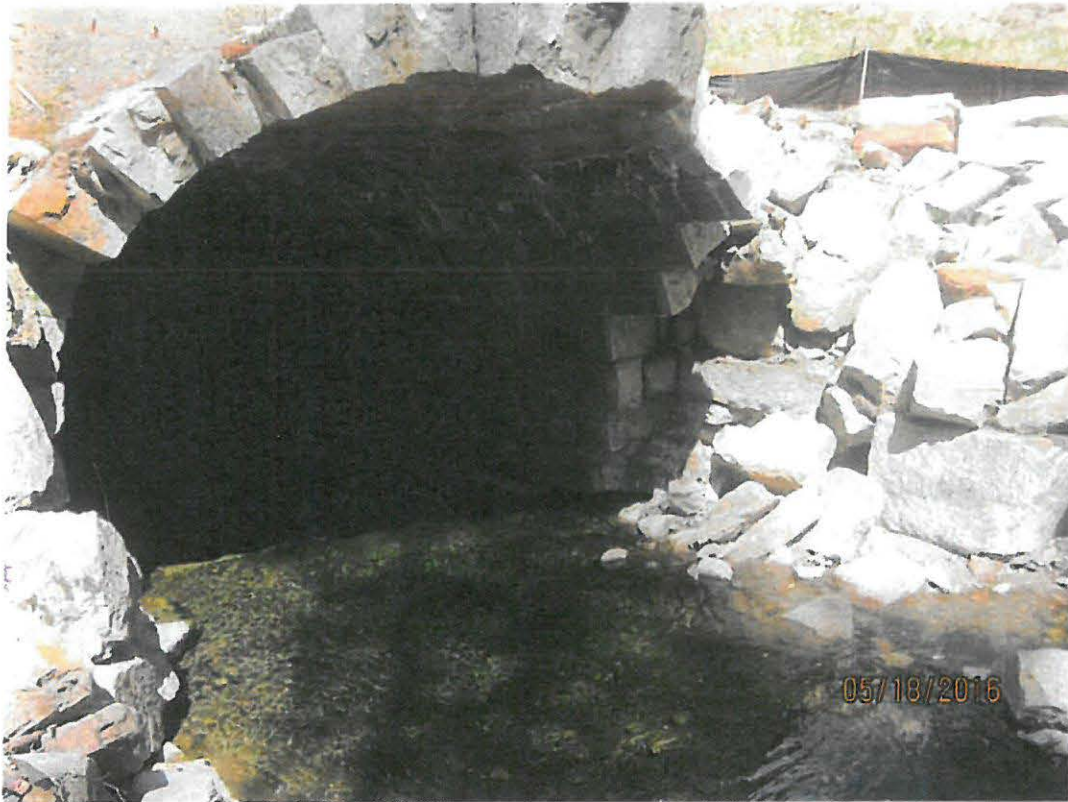
The critical part of granite arches are the foundation blocks that support the arch. At these two arches the foundation blocks are already partially undermined and susceptible to further erosion. If these blocks become totally undermined by water flow and become loose or fall out, then the blocks above become unstable and begin to move and eventually fall out causing that portion of the arch to collapse.

**View of Undermined Right Side of Arch**

The majority of the requested funds will be used to construct a new headwall on the outlet end of the Westmoreland granite arch to permanently stabilize the arch. The remaining funds will be used for engineering, plan preparation, DES permits, constructing rip rap outlet side slopes and completing the permanent restoration of the embankment slopes over the arch.

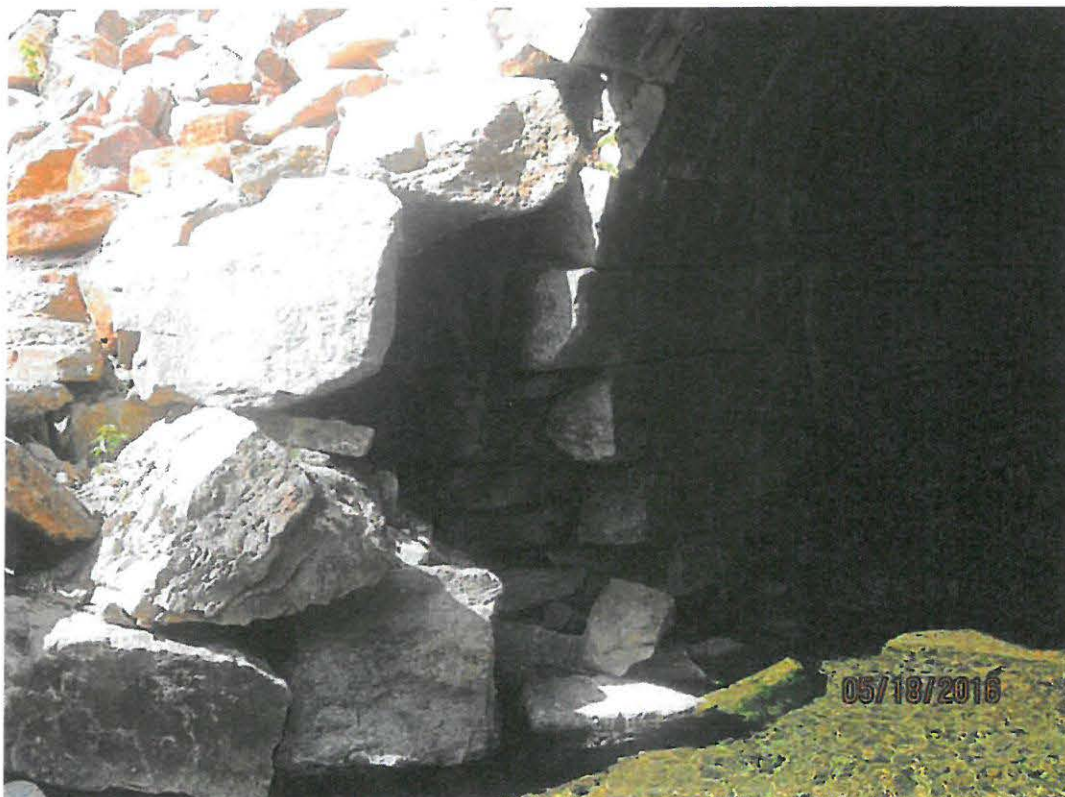
**View of Undermined Left Side of Arch**

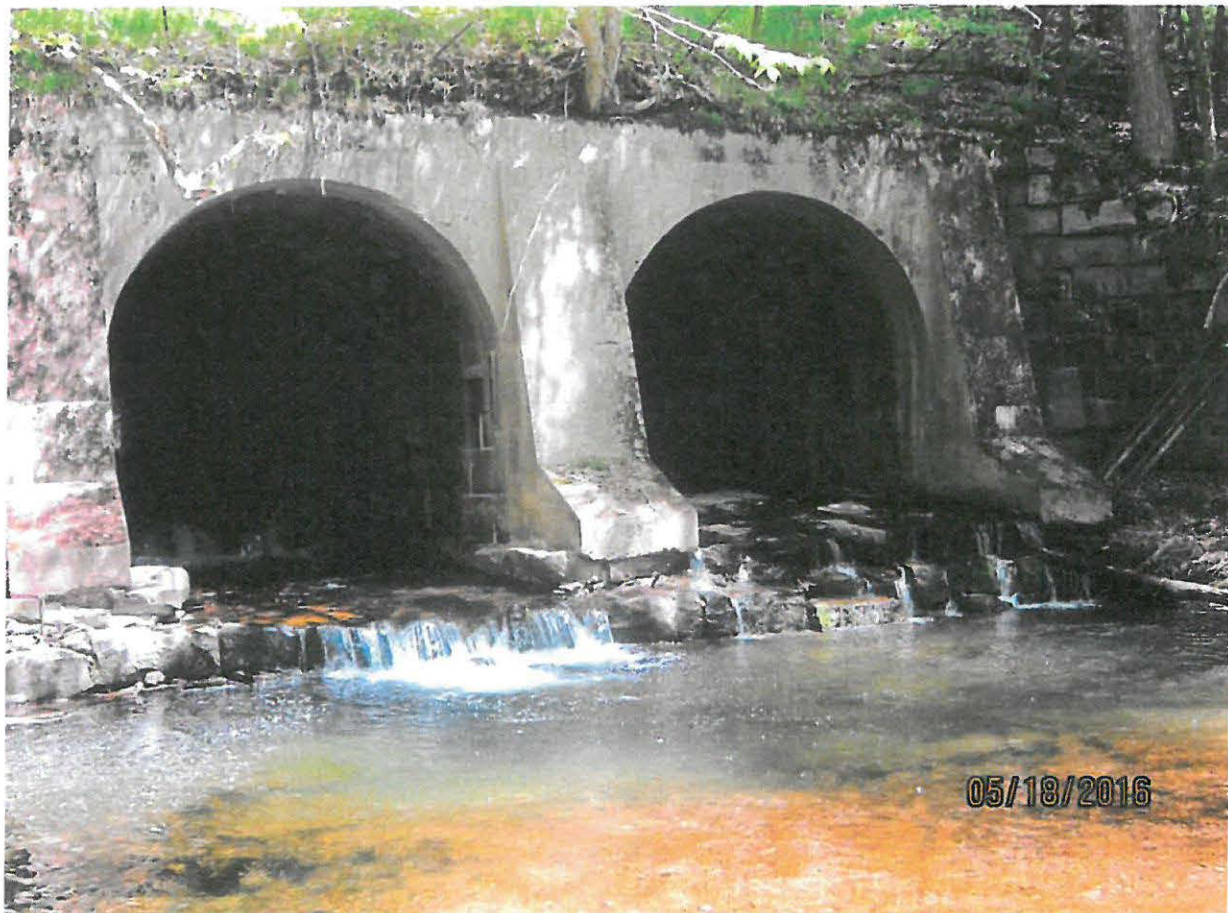
Walpole Granite Arch B106.65 is a twin arch that has deteriorated at the outlet end and inside a portion of the north arch. The previous railroad owner made substantial repairs to the outlet end of the arch during the time they owned the corridor. In the 2012 inspection of the arch, the Department found that the granite block spillway wall at the outlet end had many loose blocks and some were already missing. Funds were requested at that time for repairs, but none were provided.

**Current View of Arch Showing Deterioration at Outlet End**

The majority of the requested funds will be used to construct a concrete floor at the end of the north arch and a new concrete spillway wall at the outlet end of both arches. The work is required to prevent future damage and possible collapse of the arch, the cleanup cost of which could exceed \$700,000. The remaining funds will be used for engineering, plan preparation, NH DES permits, constructing site access and constructing rip rap outlet protection. The Department has made emergency repairs in the past, but major repairs still remain to be made at this arch to ensure that the arch is stabilized and not in danger of future deterioration and possible collapse during a severe storm event.

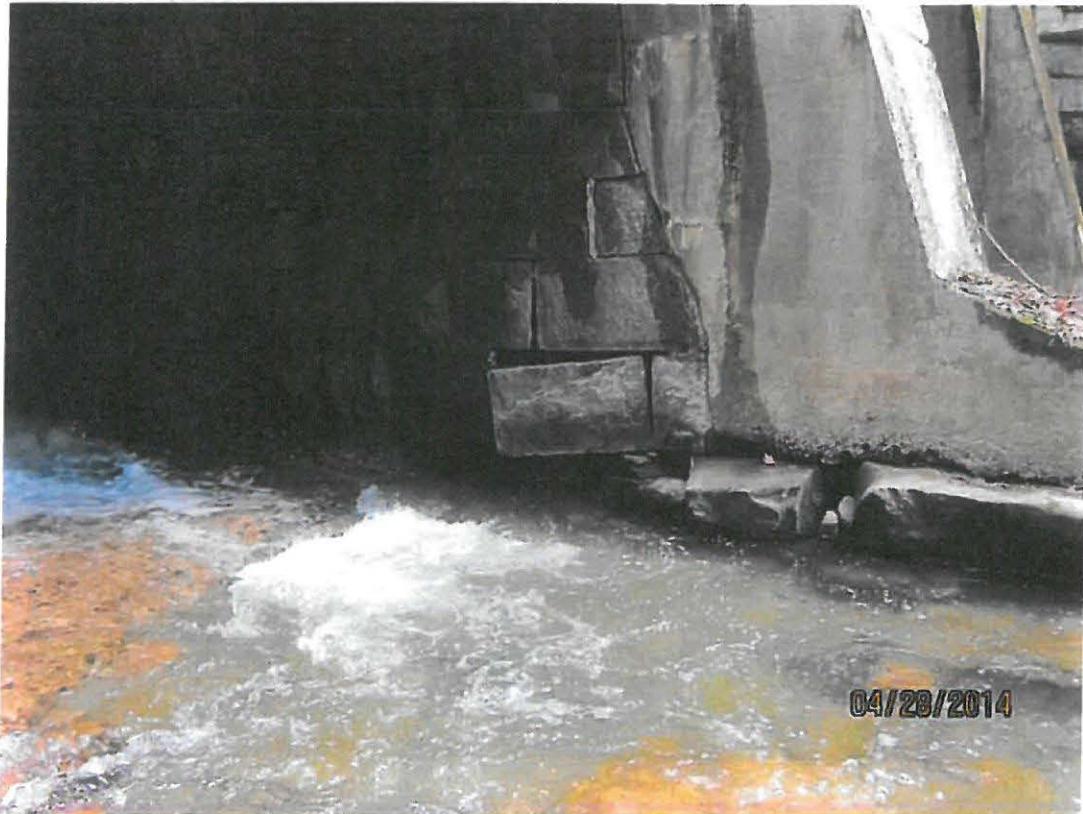
In 2014 during a reinspection of the arch following the 2013 flooding in the area, the Department found that several additional granite blocks had become dislodged at the outlet and some had been washed away. In addition, several of the blocks in the north arch were undermined and beginning to fall out. The loss of these foundation blocks inside the arch and at the spillway wall have destabilized the arch structure and may eventually cause a partial collapse similar to what happened at the Westmoreland granite arch if not remedied. In 2015, the Department performed a temporary repair to reset some granite blocks and construct a partial concrete toe wall in the north arch to stabilize the arch's foundation blocks. No repairs were made to the spillway blocks due to the lack of funding. The work inside the arch was a temporary repair until funding could be obtained to reestablish the concrete floor in the north arch, construct a new outlet spillway wall, and to repair the other arch structure issues so the arch would be in a permanent stable condition. To date that funding has not been provided.

**View of Undermined Granite Blocks in 2014**

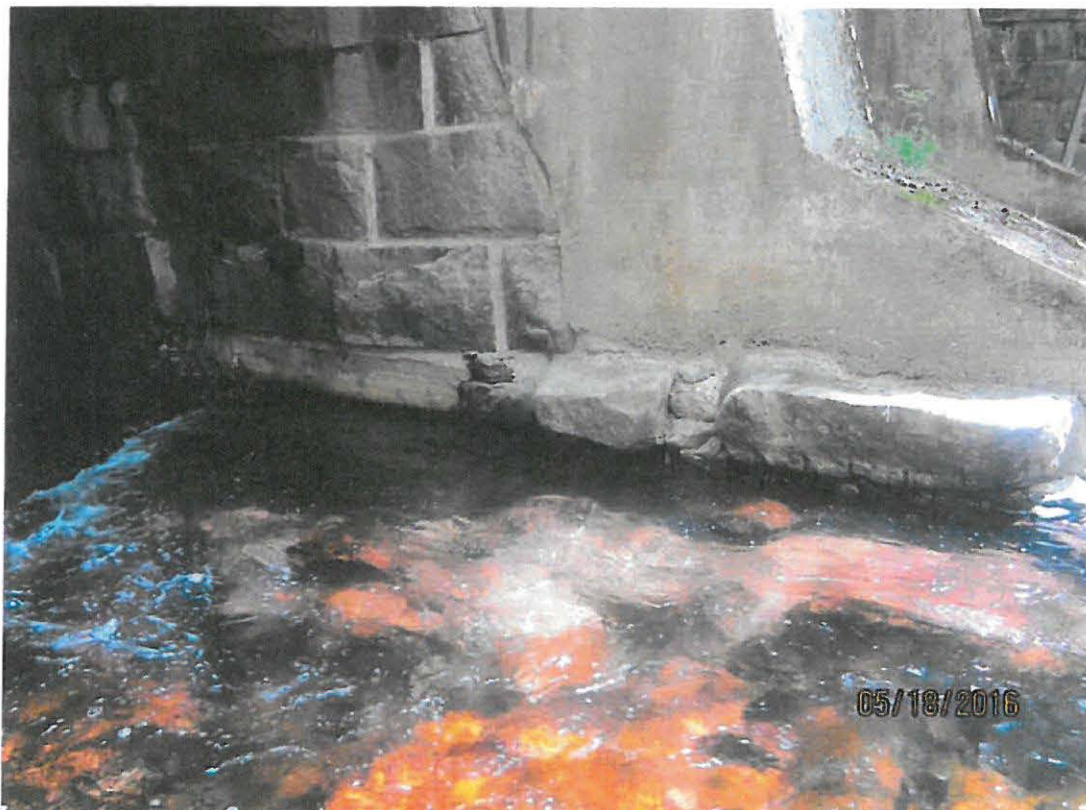
**View of Reset Granite Blocks and Concrete Completed in 2015**

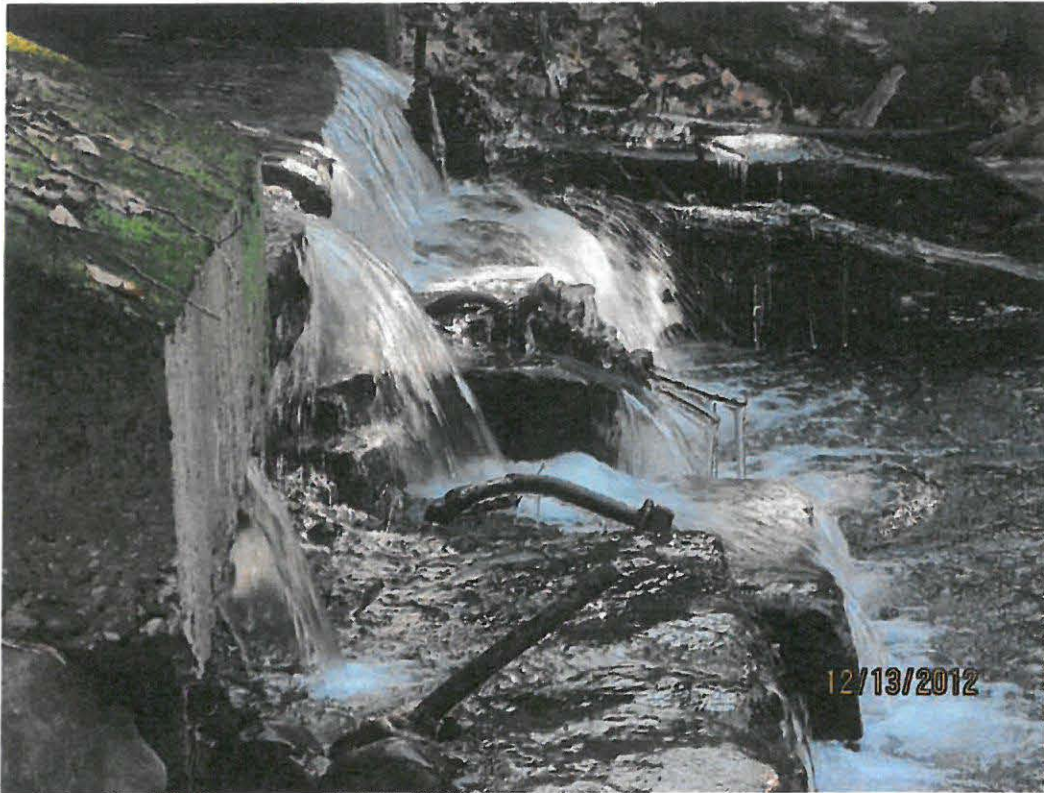
**View of South Side of Outlet Spillway Wall Showing Deterioration**

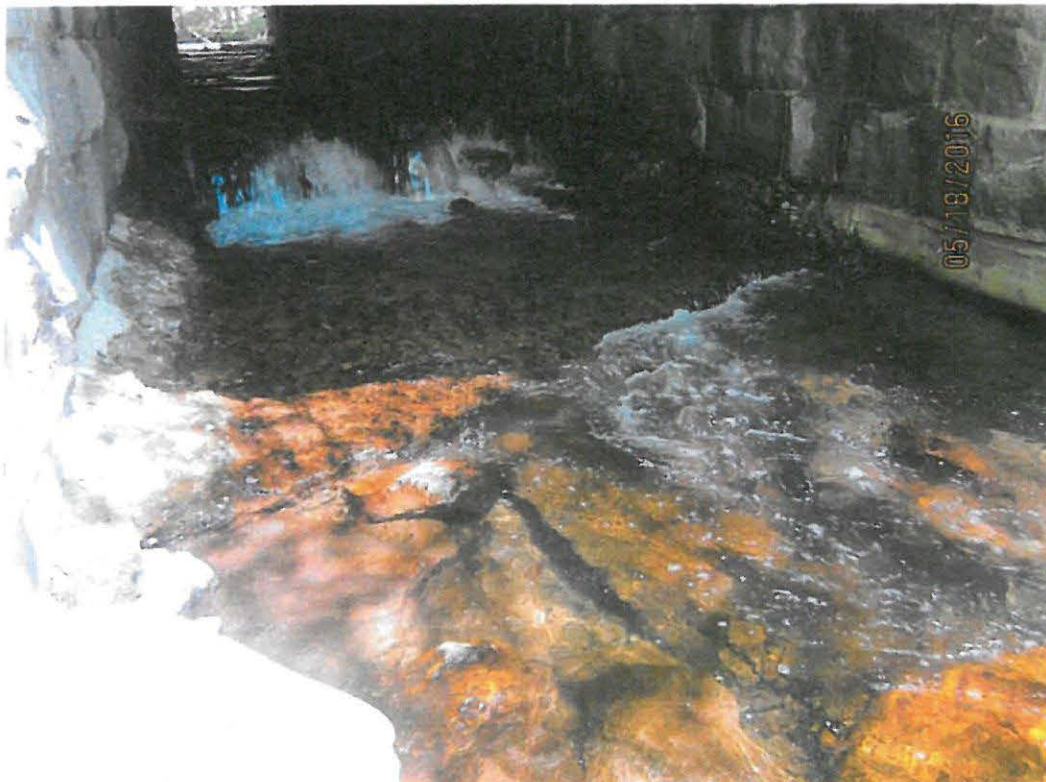
**View of Missing Floor Slabs inside the North Arch**
